PERFORMANCE DETERIORATION
DUE TO ACCEPTANCE TESTING AND FLIGHT LOADS
JT9D JET ENGINE DIAGNOSTICS PROGRAM

W. J. Olsson

UNITED TECHNOLOGIES CORPORATION
Pratt & Whitney Aircraft Group
Commercial Products Division

1. Report No. NASA CR-165572		2. Government Accession No.		3. Recipient's Catalog No.	
4. Title and Subtitle Performance Deterioration due to Acceptance Testing and Flight Loads; JT9D Jet Engine Diagnostic Program				5. Report Date January 22, 1982

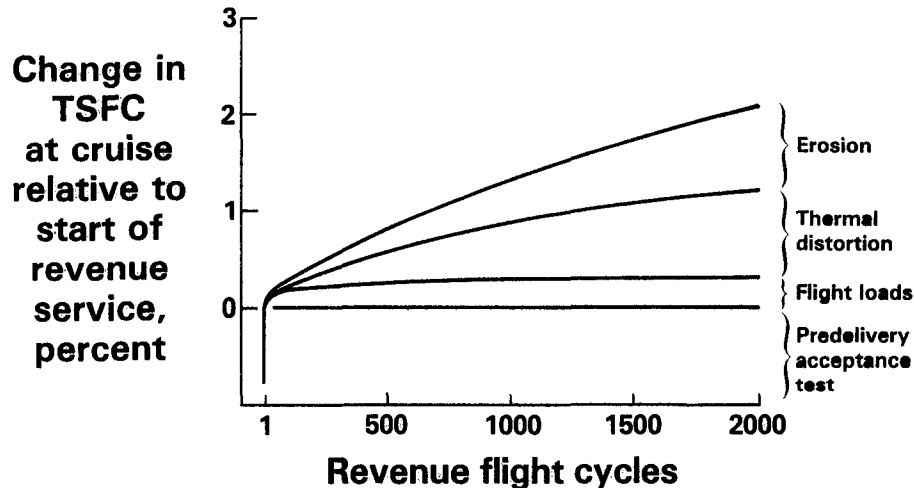
- o Rub-induced clearance changes cause a 0.8 percent increase in cruise thrust specific fuel consumption (TSFC) during production aircraft acceptance testing and an additional 0.3 percent during revenue service. This short-term effect combined with the

long-term deterioration effect results in a total of 2.1 percent increase in thrust specific fuel consumption in 2000 flight cycles for an unrepaired engine. These influences are illustrated in Figure 1-1.

Figure 1-1 JT9D-7 Engine Performance Deterioration at Cruise - Combined short-term and long-term deterioration effects result in a total of 2.1 percent increase in thrust specific fuel consumption in 2000 flight cycles for an unrepaired engine. (J26216-21)

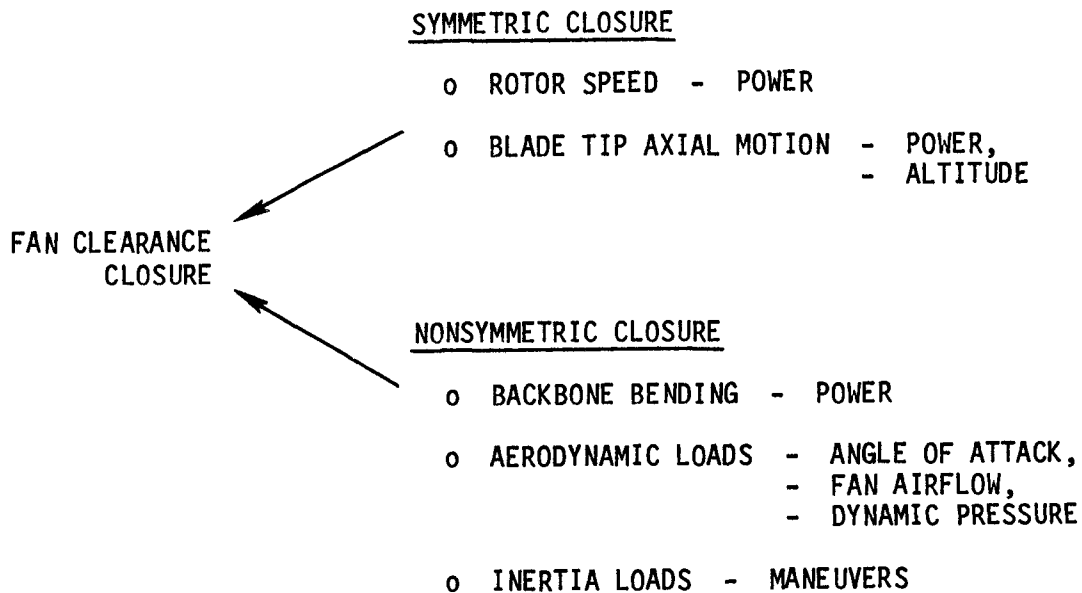
Figure 5-1 Fan Clearance Closure - Closure in the fan results from engine power, altitude, angle of attack, fan airflow, dynamic pressure, and maneuvers.

Analysis of the test data established that fan clearance closures are a combination of axisymmetric closures and asymmetric closures, as previously outlined on Figure 5-1. Axisymmetric closures are caused by engine power-induced loads. The combination of centrifugal growth and axial deflection of the rotor/blade assembly establishes the axisymmetrical closures. Asymmetric closures are caused by both engine and externally generated forces. Backbone bending forces due to thrust deflect and ovalize the fan case, reducing running clearance at the bottom. Aerodynamic loads further deflect and ovalize the fan case. Finally, inertia loads cause additional asymmetric closures.

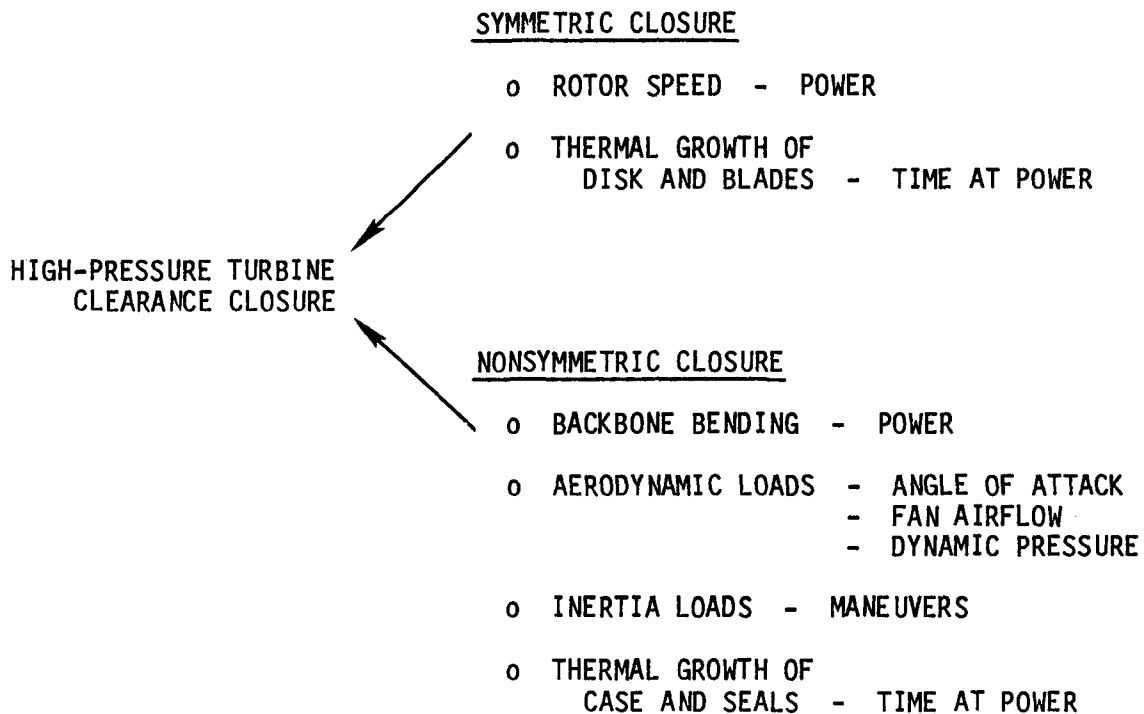
Figure 5-2 High-Pressure Turbine Clearance Closure - Closure in the turbine results from engine power, time at power, angle of attack, fan airflow, dynamic pressure, and maneuvers.

High-pressure turbine clearance closures are the combined effect of axisymmetric closures and asymmetric closures, see Figure 5-2. Analysis of the data established that rotor speed-induced centrifugal force and thrust-induced "backbone" bending are nearly instantaneous clearance change effects following a power change. Thermal expansion of blades, seals, cases, and disks are time and power-level dependent contributors to clearance closure. Finally, inertia- and aerodynamic load-induced asymmetric closures will further pinch the turbine running clearances. Section 5.3.2 discusses the magnitude and timing of power-induced and flight load-induced closure and their combined effect on turbine running clearances.

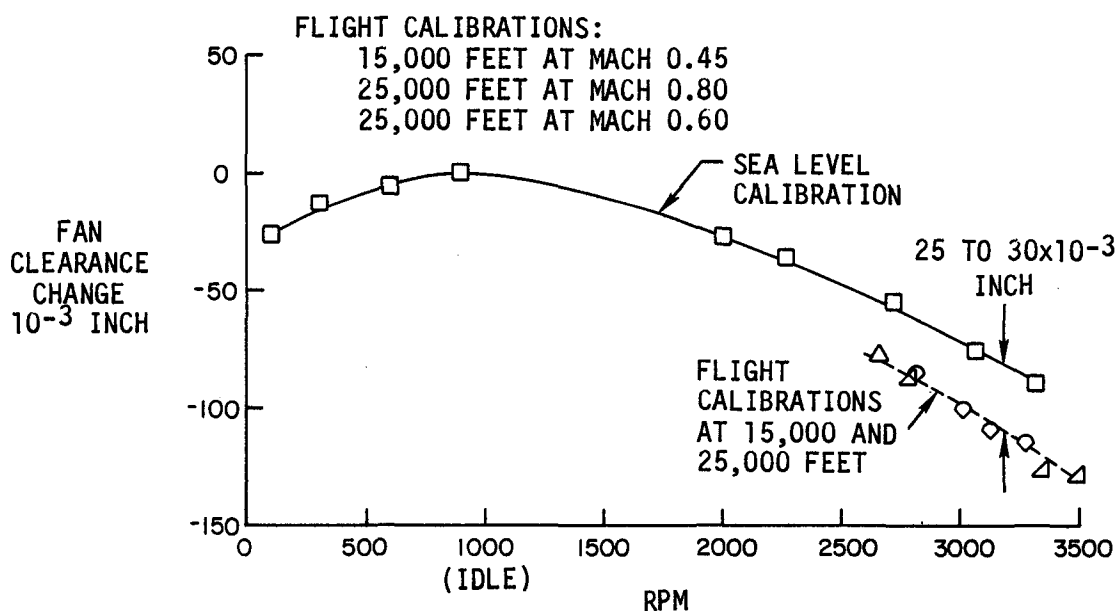
Measured axisymmetric fan clearance change from a stabilized ground idle is presented in Figure 5-3 as a function of low-pressure rotor (N) speed, both on the ground and at altitude, based on ground and flight calibration data. The net thermal expansion effect on the fan rotor and case is also included in Figure 5-3. Axisymmetric clearance closures for the position number 3 fan at each of the test conditions are summarized on Table 5-1, column 1.

Figure 5-3 Measured Axisymmetric Fan Clearance Change - Ground and flight calibration data show that clearances are tighter at altitude compared to sea level for a given engine speed.

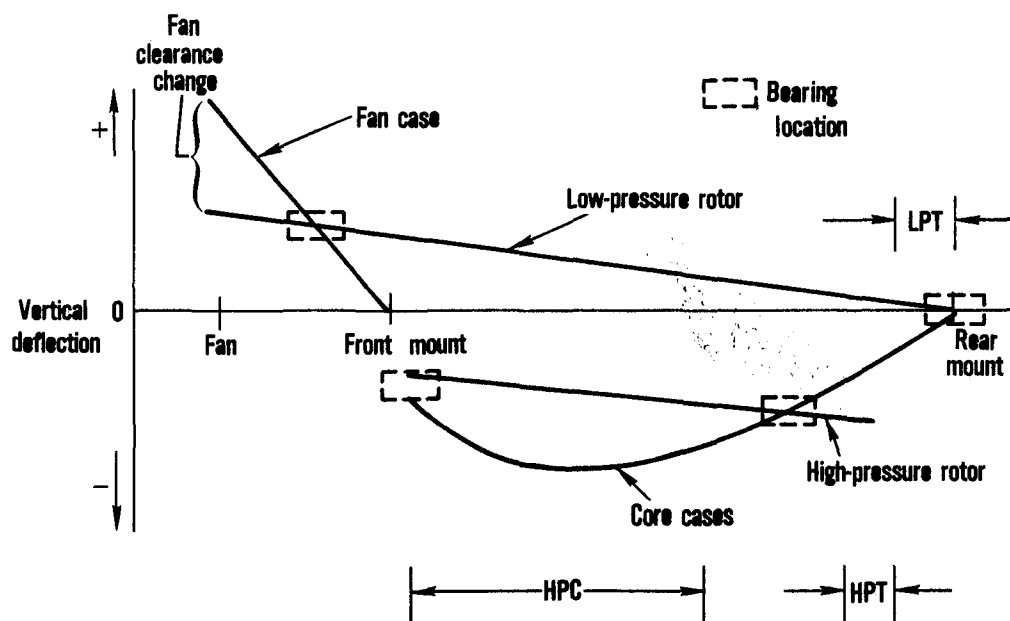
Since the thrust reaction is carried through the thrust frame, which is offset 30 degrees above the engine horizontal centerline, there is a backbone bending moment generated about the engine horizontal axis. The resulting engine bending (as illustrated in Figure 5-4) causes the front flange of the fan case to deflect upward more than the front section of the low-pressure rotor which results in reduced fan blade clearance at the bottom of the engine. The thrust load effects on blade clearances in the position number 3 fan for each of the test conditions are shown on Table 5-I, column 2.

Figure 5-4 Typical Backbone Bending Plot for the JT9D Engine - A backbone bending moment resulting from the engine thrust reaction causes the front flange of the fan to deflect upward more than the front section of the low-pressure rotor. (J24318-1)

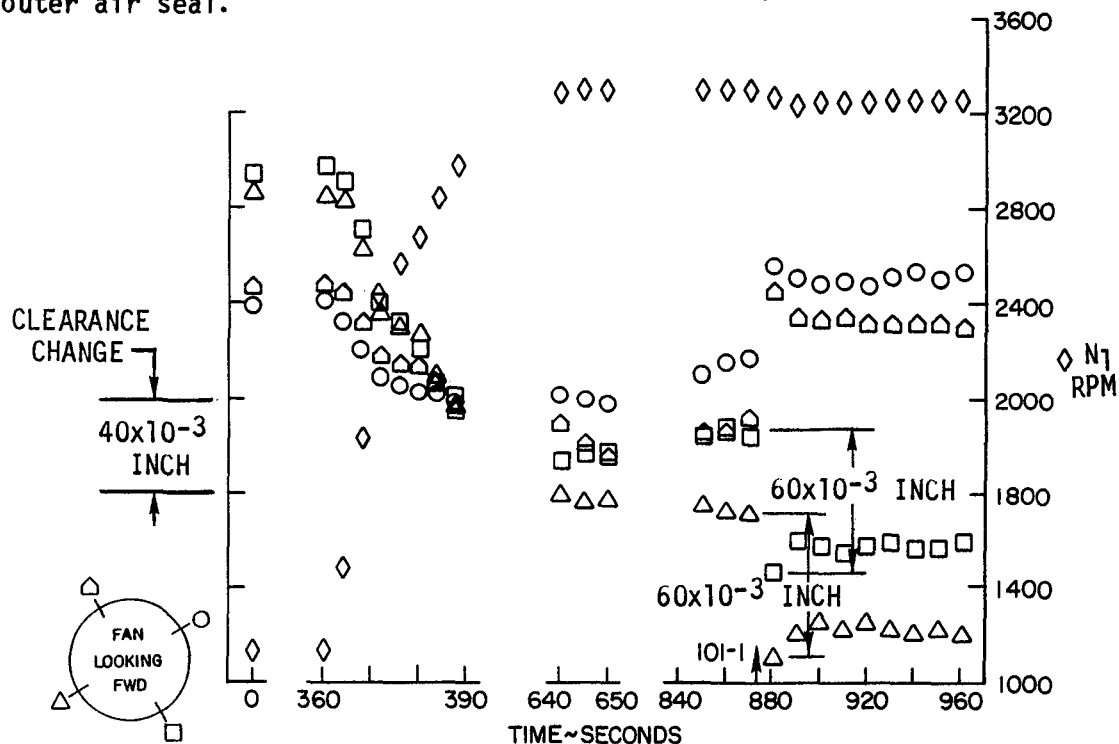
The combined effects of power loads on fan running clearances are shown on Figure 5-5 which plots the running clearance measured at the four probe locations during a stabilized ground idle, run up to power, ground calibration, and the first test take-off. The probe locations are shown in the lower left hand corner of the figure. Engine power level is proportional to the plotted fan rotor speed (N_1). Reading from the left, the engine operated at stabilized ground idle for 6 minutes. The running clearance indicated by the lower probes is about 0.050 inch greater than at the top due to the offset grind in the fan outer air seal.

Figure 5-5 Change in Fan Running Clearance from Stabilized Ground Idle to the First Take-Off - Thrust and air loads are additive in closing clearances at the bottom of the position number 3 fan.

The engine was then accelerated to approximately 80 percent of take-off power. As engine speed increased, the centrifugal force effect axisymmetrically reduced the running clearance at all four probe locations. This effect can be seen in Figure 5-5 during the initial 10 seconds of the acceleration. As the static thrust increased, the

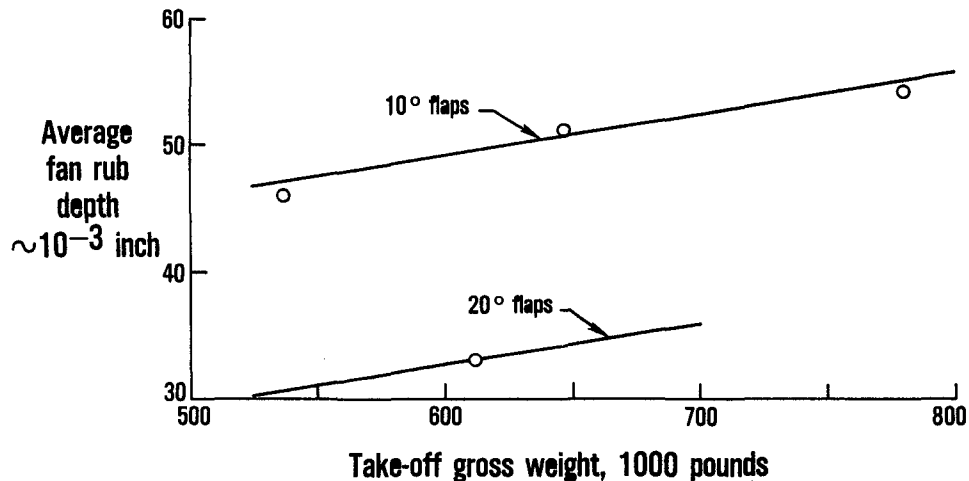
The Third and fourth take-offs (Conditions 101-3 and 118) were also conducted at full power and with 10-degree flaps for both tests. However, gross weights were increased to establish the effect of weight on aerodynamic load and the resulting clearance closure. The rotation angles were about equal to that of Condition 101-2. However, the rotation speed (Table 3-I) increased with higher gross weight. The result was an increasing aerodynamic load and clearance closure (Table 5-I and Figure 5-7) with increasing take-off gross weight, at constant power and flap setting, due to the higher dynamic pressure (speed) at rotation. Figure 5-7 shows that change in flap setting has a greater effect than gross weight on fan clearance closure and rub depth.

Figure 5-7 Effect of Take-Off Gross Weight and Flap Setting on Fan Clearance Closure at Take-Off - Change in flap setting has a greater effect than gross weight on fan clearance closure and rub depth.

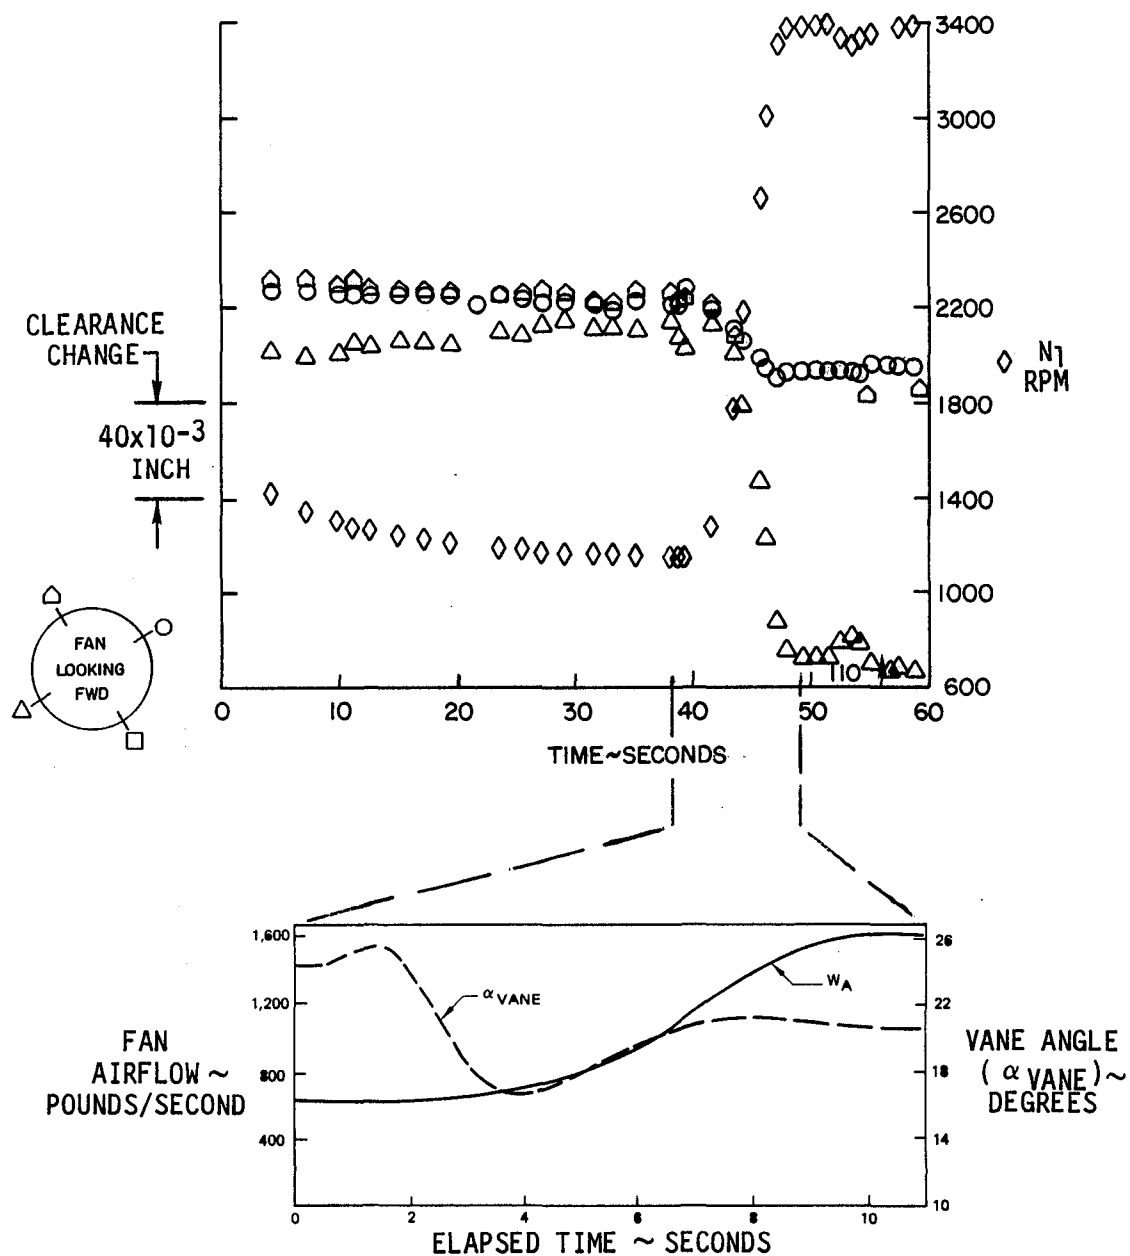
The stall warning conditions (flight conditions 109, 110, and 111), which were part of airplane acceptance testing and the inadvertent airplane stall (condition 123), provided good examples of the combined effect of high angle of attack and high fan airflow rate. The stall warning condition 110, see Figure 5-8, establishes that both high fan airflow and high vane angle are required. As seen on the double plot in this figure, prior to the stall warning the vane angle is high (25 degrees) and the engine speed and, thus, airflow rate are low. The asymmetric clearance closure is small as shown by the close spread between probe readings.

Figure 5-8 Change in Fan Running Clearance During the Stall Warning (Condition 110) - The stall avoidance maneuver and the accompanying increase in engine speed and fan airflow rate resulted in a rapid increase in both the axisymmetric and asymmetric closure.

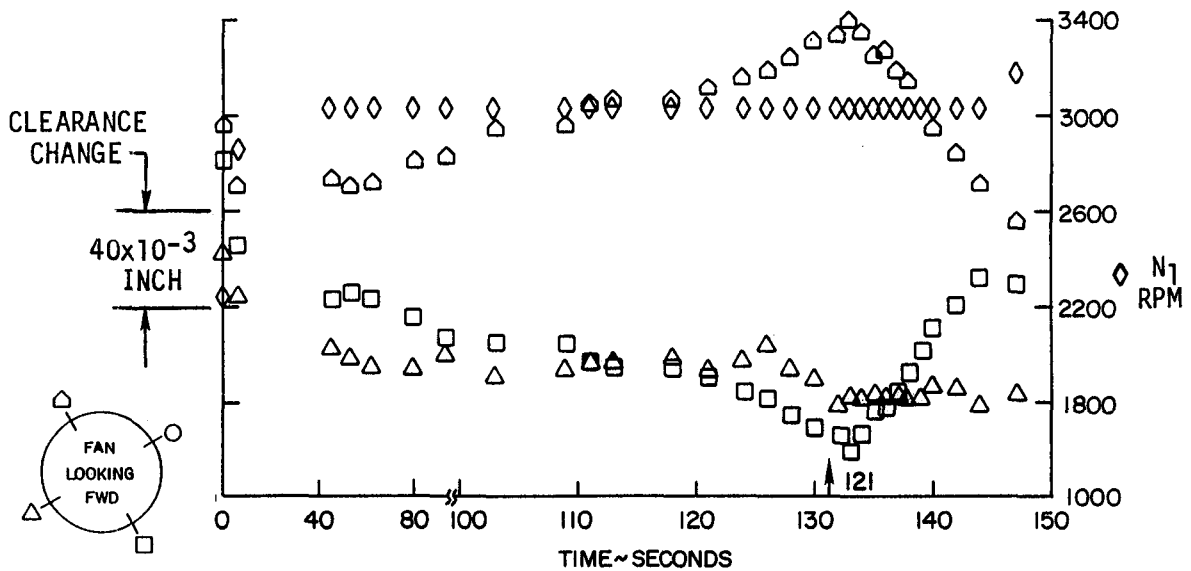
High G turn simulated avoidance maneuvers provided the other maximum clearance closure condition in the fan. The effect of increasing angle of attack (in the turn) while flying at a constant engine speed is shown in the measured clearance data plot of the 1.6-G turn, condition 121. This plot is shown in Figure 5-9.

Figure 5-9 Change in Fan Running Clearance During a High G Turn Simulated Avoidance Maneuver (Condition 121) - The increasing angle of attack in the turn at constant engine speed resulted in an increased aerodynamic load-induced closure in the position number 3 fan.

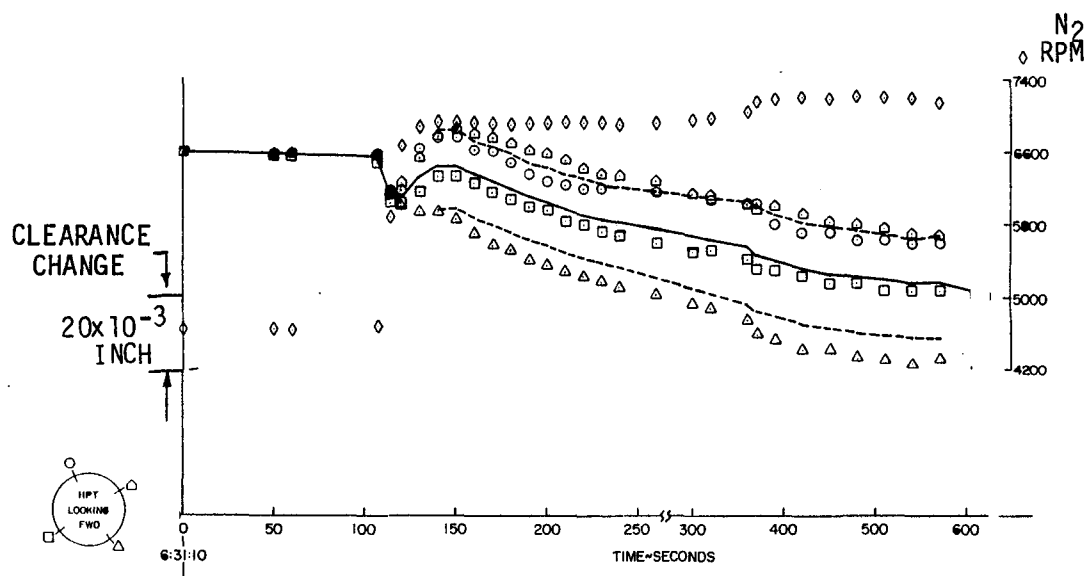
These various power effects on high-pressure turbine running clearances are seen in Figure 5-14 which is a plot of the measured clearance changes at four probe locations during a high power ground calibration starting at a stabilized ground idle condition. The plot shows the transient and steady state effects of power induced loads on running clearances in the high-pressure turbine.

The magnitude and timing of these various effects is shown in Figure 5-14. The initial effect of the acceleration at 115 seconds is an axisymmetrical closure due to centrifugal forces. The net effect of thermal expansion of the blade and case then increases the axisymmetrical clearance. Concurrently, as thrust is increased, the backbone bending effect asymmetrically closes the clearance at the bottom of the engine and opens the clearance at the top as illustrated by the spread between symbols on the figure. The thermal expansion of the disk is seen next as it causes a slower axisymmetrical closure which was still in progress when the engine power level was increased again at 360 seconds. The immediate effects of this acceleration are additional closures induced by centrifugal load and backbone bending load. These closures are followed by additional disk expansion which continues out to the end of the test run when clearances have nearly stabilized.

Figure 5-14 Effects on High-Pressure Turbine Clearance due to Power-Induced Take-Off Loads (Condition 101-1) - Both axisymmetric and asymmetric closures increased with increasing power setting.

As can be seen on the figure, the nonuniform thermal load-induced closure appears to increase with power level, with maximum closure occurring in the lower right hand quadrant of the engine.

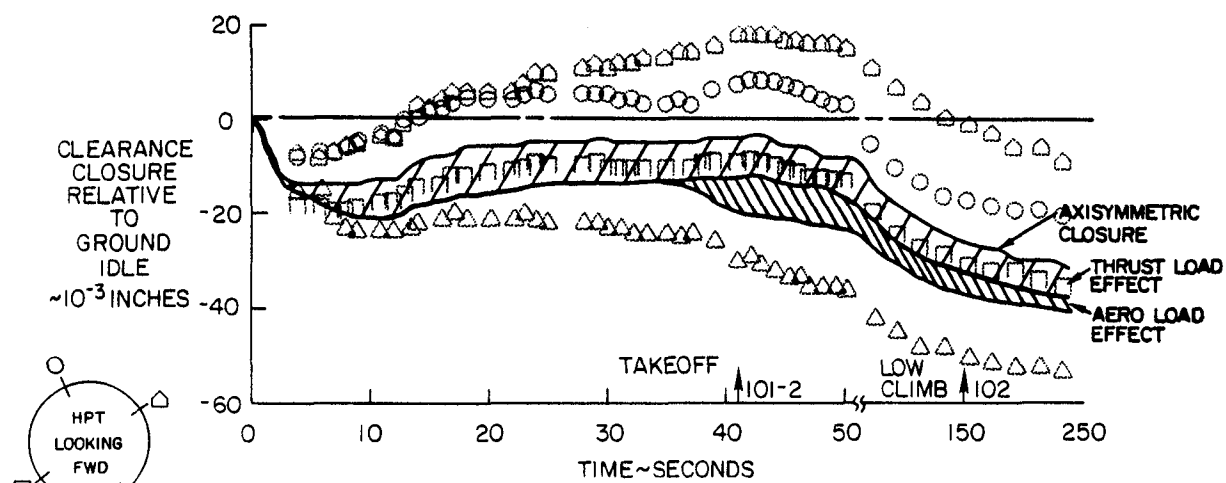
Figure 5-15 Axisymmetric and Asymmetric Clearance Closures During Typical Take-Off and Climb - The minimum clearance pinch occurred about 200 seconds into the climb.

The net effect is small at take-off since the rapid thermal expansion of the case tends to open rather than close clearances as seen on Figure 5-15B. After 200 seconds of climb power, the disk has absorbed sufficient heat to complete its thermal expansion.

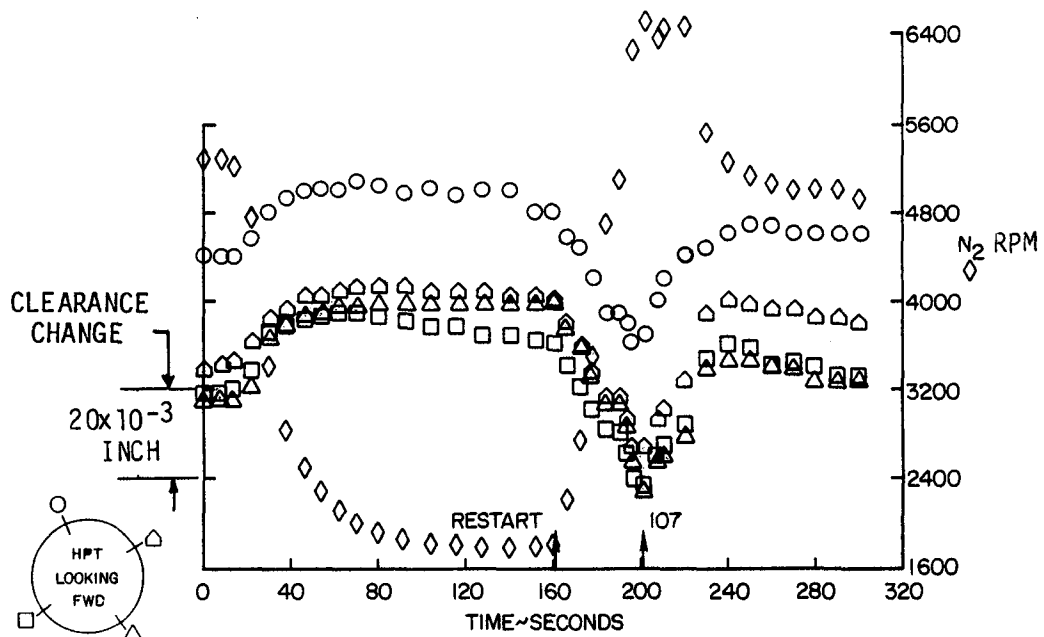
Figure 5-16 Change in High-Pressure Turbine Running Clearance During the In-Flight Shutdown and Restart (Condition 107) - Quick restart of an engine with a hot rotor can result in significant clearance closure.

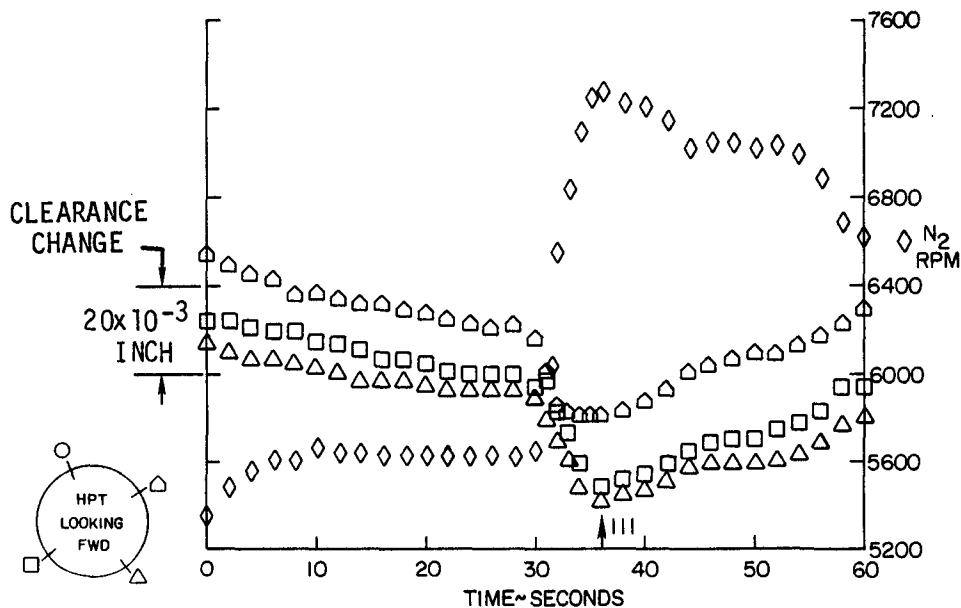
Figure 5-17 Change in High-Pressure Turbine Running Clearance During the Stall Warning (Condition 111) - Quick acceleration of an engine with a hot rotor can result in significant clearance closure.

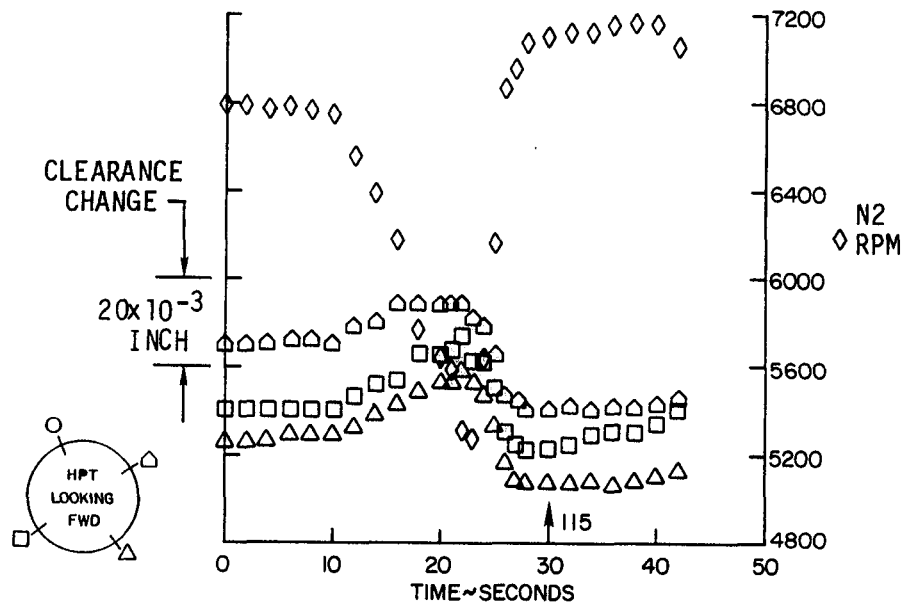
Figure 5-18 Change in High-Pressure Turbine Running Clearance During Thrust Reversal (Condition 115) - Quick acceleration of an engine with a hot rotor can result in significant clearance closure.

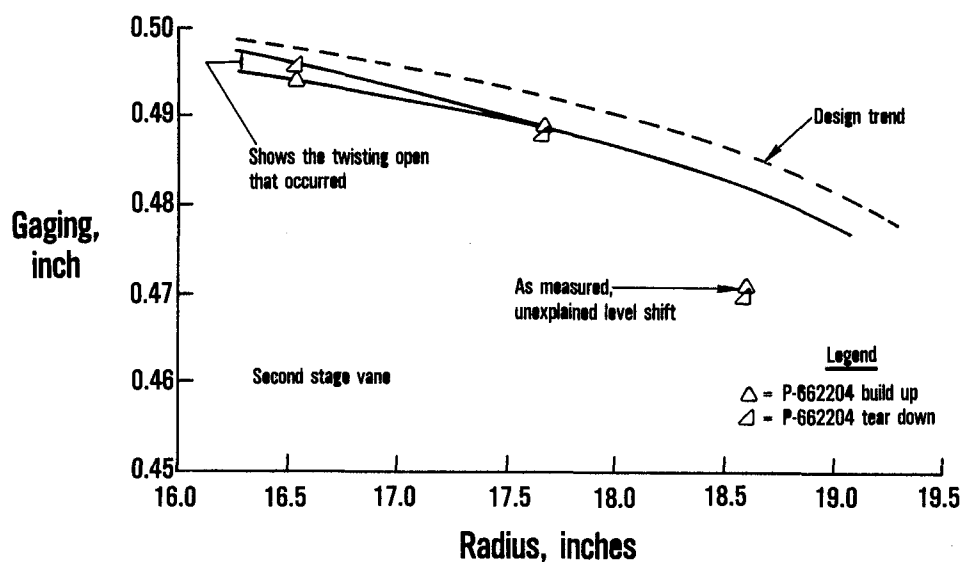
Vane inner diameter twisting was evaluated by measuring the change in the axial distance between the vane inner feet (see Figure 5-19). Based on the before and after measurements on 15 vanes, the axial distance increased an average of 0.0022 inch. The Simpson's rule measurement also showed the twisting of the inner-diameter portion of the vane (see Figure 5-20).

Figure 5-20 Comparison of Methods of Vane Twist Measurements - Simpson's Rule results is in good agreement with measurement of the change in axial distance between the vane inner feet.

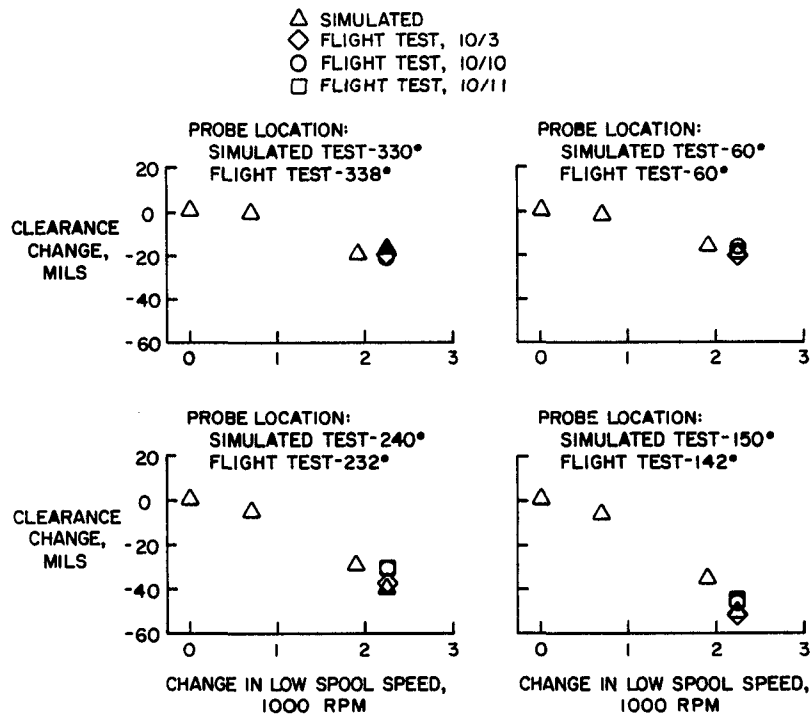
Power load-induced turbine clearance closures measured during this program showed good agreement with the comparable closures measured during the Simulated Aerodynamic Loads Test program (Reference 6). Figure 5-21 compares the clearance closures at the four probes as measured in both programs. Note that clearance closure is plotted as a function of low-pressure rotor speed since it is more representative of thrust.

Figure 5-21 Comparison of Flight Loads Test Data with Simulated Aerodynamic Loads Test Data - The comparison of comparable closure data shows good agreement.

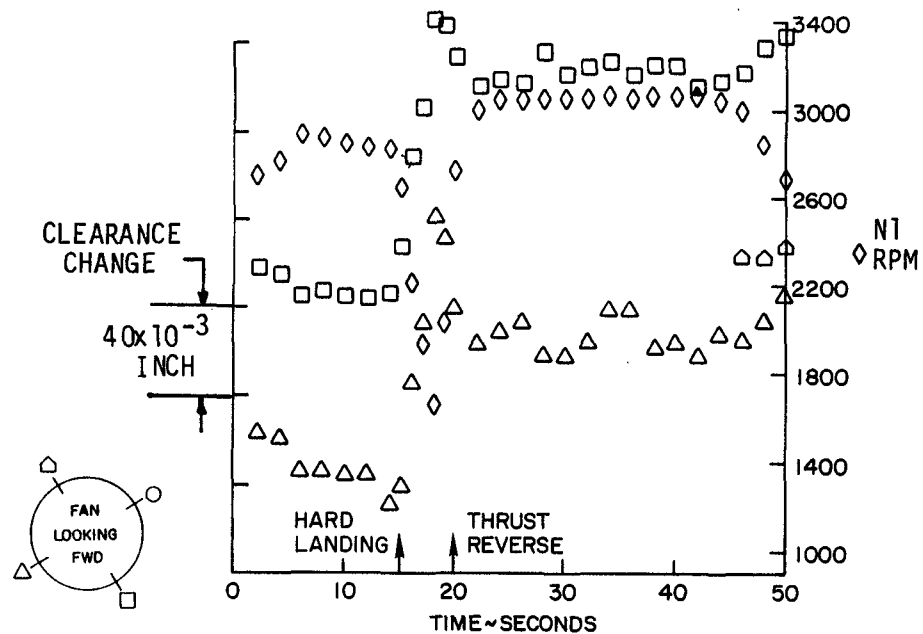
The hard landing was conducted at the end of the fourth test flight at an estimated sink rate of 5 feet/second, which is about double the normal sink rate, and an airplane gross weight of 690,000 pounds. Both approach power level and airplane angle of attack were greater than normal due to the high gross weight. Hence, the resulting aerodynamic plus thrust load-induced fan clearance closure was much greater than normal for the landing approach. At touch down, fan clearance closed an additional 0.015 inch, then opened when the engines were throttled back prior to thrust reversal (see Figure 5-24). The tightest fan clearance was equal to that at maximum gross weight take-off. There were no sharp changes in laser-monitored fan blade tip clearance at the time of touch down. Neither were there any marks in the fan rub strip to indicate sudden impact with the fan blades.

Figure 5-24 Effect of a Hard Landing on Fan Clearance - The landing at a 5 feet/second sink rate and 690,000-pound gross weight had only a small effect on clearance in the fan of the position number 3 engine.

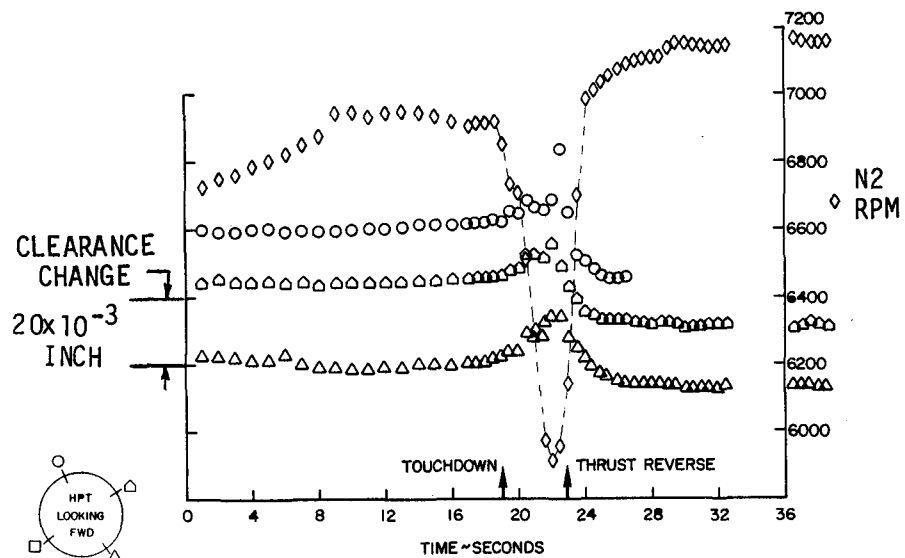
High-pressure turbine laser measured running clearance, as shown in Figure 5-25, also indicated no sudden clearance closure at touch down. High-pressure turbine running clearance (see Figure 5-25) indicated no additional clearance closure at touch down. The net result was that the high sink rate landing had small effect on fan clearance and no effect on turbine clearance. The combined result of aerodynamic forces and impact force would be even less in a high sink rate landing of a revenue service airplane where landing gross weights would not exceed 600,000 pounds.

Figure 5-25 Effect of a Hard Landing on High-Pressure Turbine Clearance - The landing at a 5 feet/second sink rate and 690,000-pound gross weight had no effect on clearance in the high-pressure turbine of the position number 3 engine.

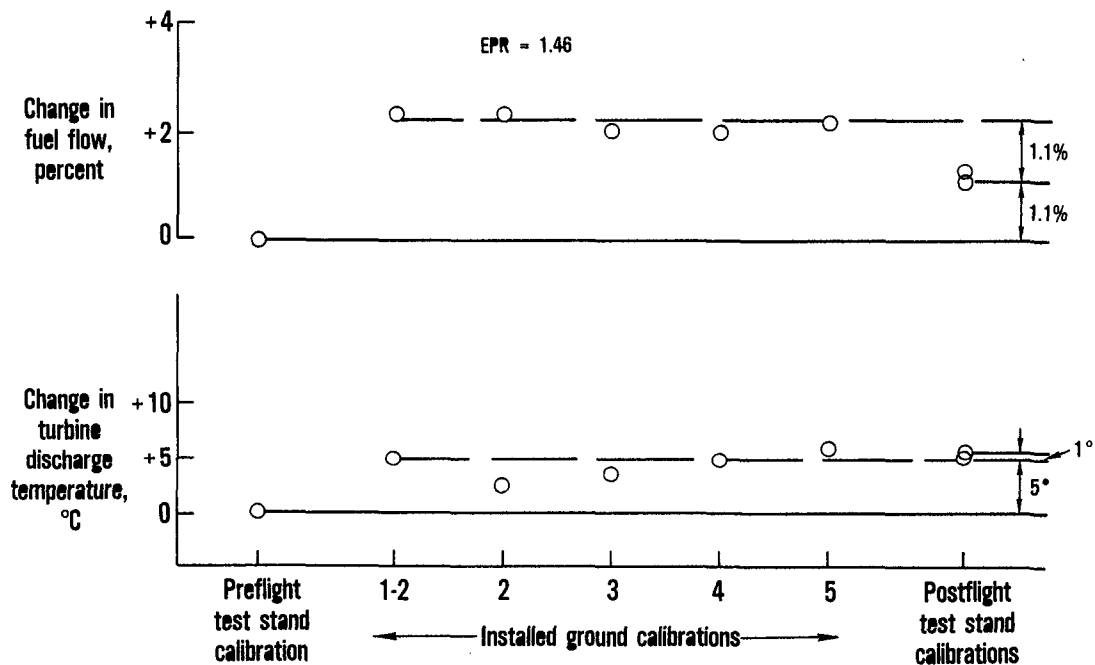
A summary of the test stand and installed calibration data (Figure 5-26) shows that most of the performance deterioration occurred between the preflight test-stand calibration and installed ground calibration 1-2. A 5°C increase in turbine exhaust gas temperature (EGT, TT7) at constant engine pressure ratio (EPR) is indicated for calibration 1-2 and for all the other installed calibrations, within experimental accuracy. The postflight test-stand calibrations agree with the installed data within about 1°C. Note that the test stand data were adjusted for the change from the test stand environment and hardware to the outdoor nacelle installation, based on previously established indoor/outdoor corrections.

Figure 5-26 Summary of Engine Calibration Results - Most of the performance deterioration occurred between the preflight test stand calibration and the first installed ground calibration (1-2).

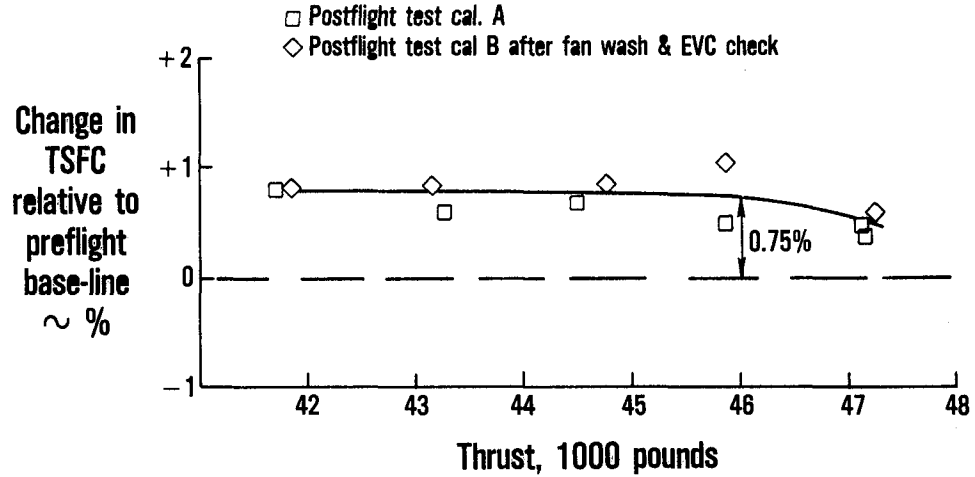
A comparison of the postflight-test sea level calibrations with the preflight-test base-line calibration shows a deterioration of 0.75 percent in thrust specific fuel consumption at 46,000 pounds thrust (Figure 5-27). Engine data indicated a loss in overall turbine efficiency of 0.4 percentage point (Figure 5-28) which is equivalent to a 0.9 percentage point loss in high-pressure turbine efficiency when no loss is assumed for the low-pressure turbine; 0.1 percent increase in high-pressure turbine flow parameter (Figure 5-29); and a 0.3 percent loss in fan flow capacity (Figure 5-30). Changes in gas generator characteristics of the engine at high power are listed on Table 5-VI along with the estimated impacts of module deterioration on those characteristics. Only high-pressure turbine and fan deterioration were considered, since these were the only gas-path modules that were refurbished prior to this program. The other modules were high-time units and were less sensitive to rub-induced performance deterioration. Best agreement between the estimated gas generator changes and the measured changes was achieved with the 0.9 percentage point loss in high-pressure turbine efficiency, 0.1 percent increase in high-pressure turbine flow parameter, and 0.3 percent loss in fan flow capacity noted above combined with a 0.4 point loss in fan efficiency. Thus, the measured module changes, where available, and those implied by gas generator shifts are in agreement.

Figure 5-27 Overall Performance Deterioration at Sea Level from Preflight Test-Stand Base-Line Calibration to Postflight Test-Stand Calibrations - The data indicate a thrust specific fuel consumption loss of 0.75 percent at a thrust level of 46,000 pounds.

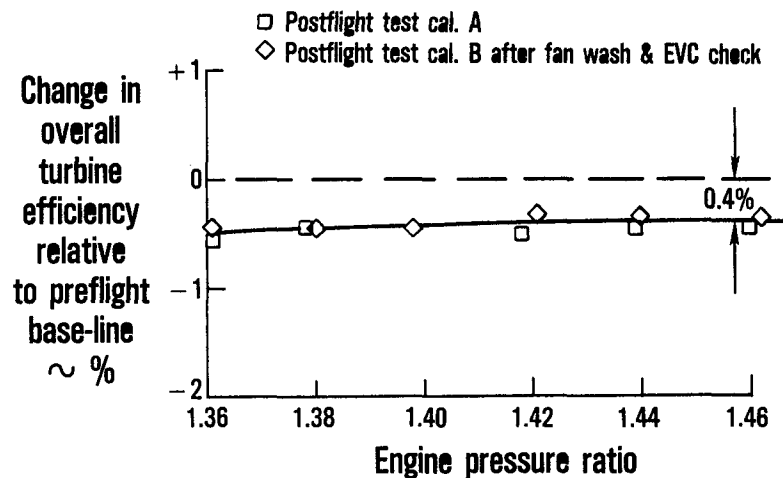
Figure 5-28 Turbine Efficiency Loss from Preflight Test-Stand Base-Line Calibration to Postflight Test-Stand Calibrations - The data indicate an overall turbine efficiency loss of 0.4 percentage point at an engine pressure ratio of 1.46.

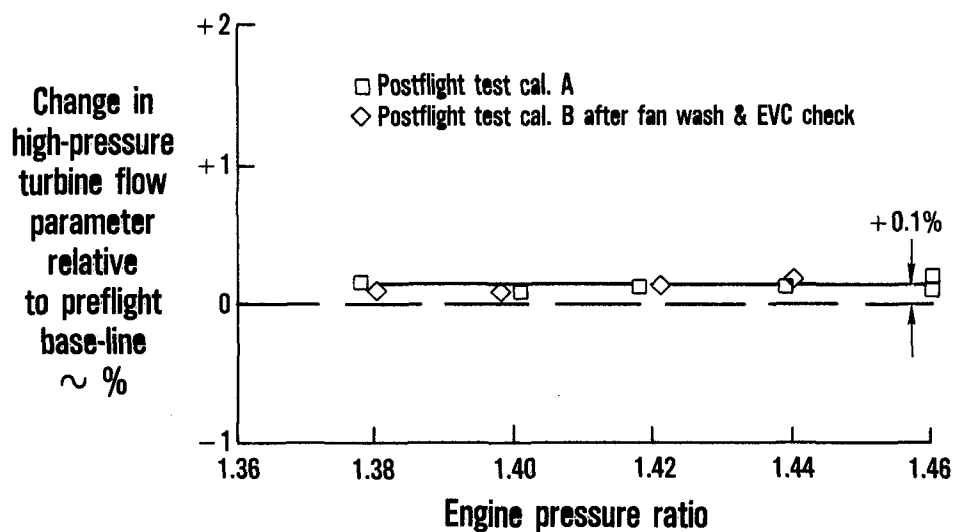
Figure 5-29 High-Pressure Turbine Flow Parameter Change from Preflight Test-Stand Base-Line to Postflight Test-Stand Calibrations - The data indicate a high-pressure turbine flow parameter increase of 0.1 percent at an engine pressure ratio of 1.46.

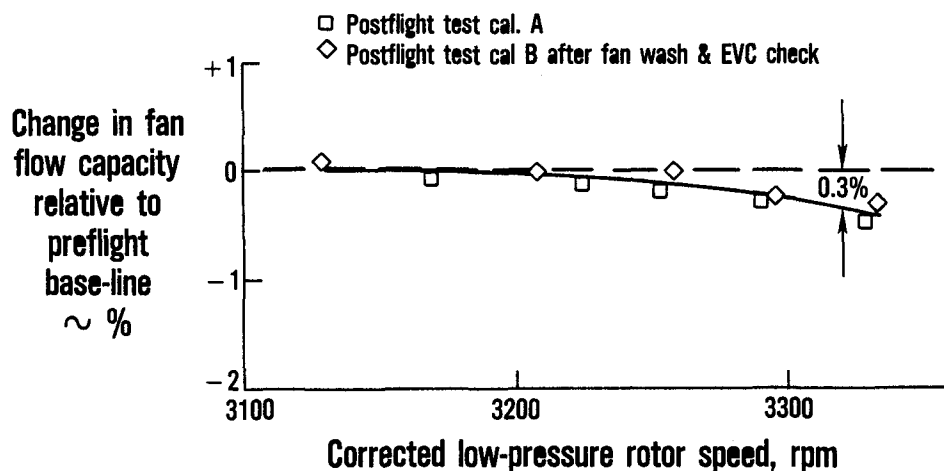
Figure 5-30 Fan Flow Capacity Loss from Preflight Test-Stand Base-Line to Postflight Test-Stand Calibrations - The data indicate a fan flow capacity loss of 0.3 percent at a corrected low-pressure rotor speed of 3320 rpm.

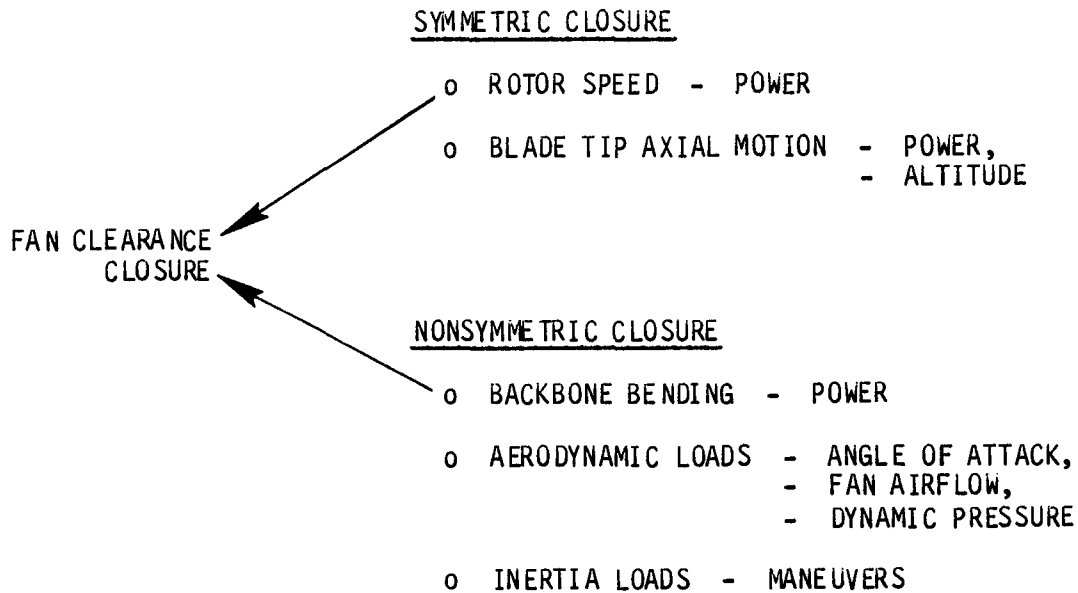
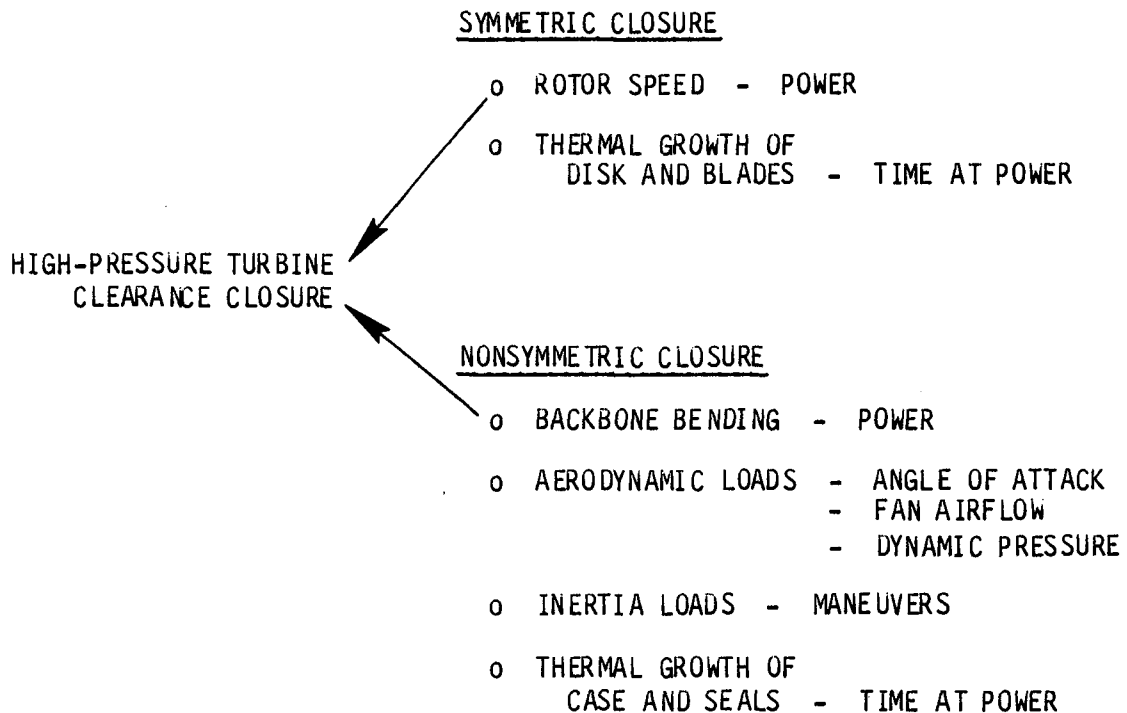
Clearance closures and the resulting rubs are caused by the sum of power effects and flight load effects as shown on Figure 7-1. The axisymmetric closures are due to thermal and mechanical loads applied either to the rotating segments or uniformly around the static segments. The asymmetric closures are due to nonsymmetric mechanical and thermal loads applied to the static structure and not necessarily in the plane of the closure.

Figure 7-1 Fan and High-Pressure Turbine Clearance Closures - Closures in these components are caused by the sum of power effects and flight load effects.

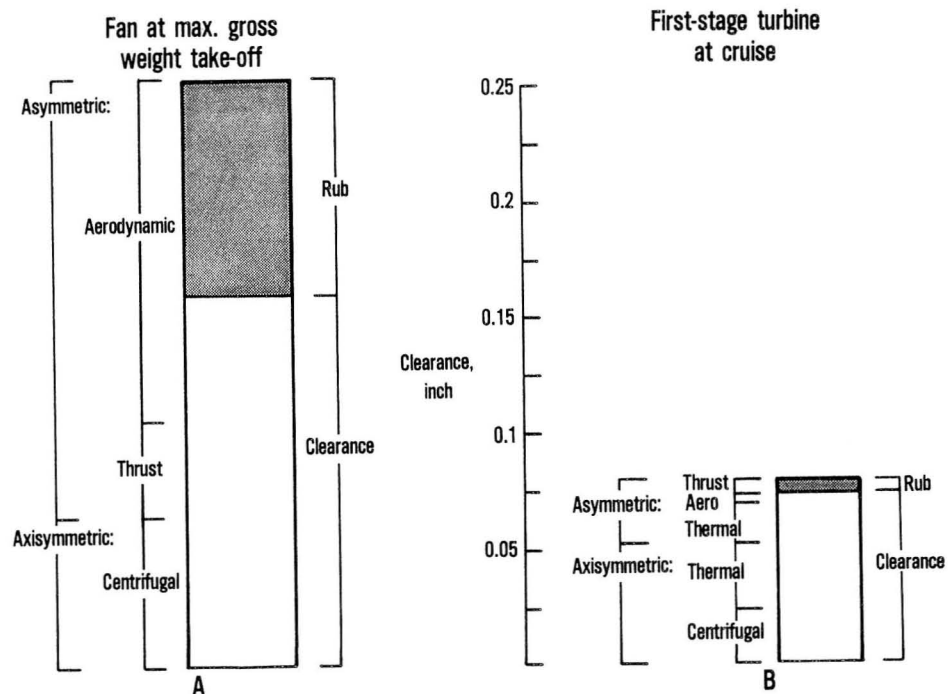
The 10-degree flap setting at take-off in the acceptance test flight required a greater rotational angle than that for take-off with a 20-degree flap setting. This increased angle of rotation resulted in increased fan closure and rub. Similarly, but to a lesser degree, fan clearance closure at take-off increased with gross weight due to the increased speed at lift-off. During the maximum gross weight, 10-degree flap setting take-off (flight condition 118), the asymmetric closures due to thrust and aerodynamic load-induced case bending exceeded 0.180 inch as shown on Figure 7-2A.

The flight test program identified midclimb as the maximum clearance closure condition in the first-stage high-pressure turbine during normal revenue service. Differential thermal expansion of rotating and static components plus the sum of the aerodynamic, centrifugal, and thrust bending effects combined to close the running clearance with the pinch occurring three to four minutes into climb and located in the lower outboard quadrant, see Figure 7-2B. Maximum closure occurs at this point due to the slow thermal expansion of the turbine disks which continued to close down the running clearances after the aerodynamic and thrust loads had peaked and started to decrease. Note that this Flight Loads Test was conducted using a JT9D-7A engine installed in a 747-200 nacelle; thus, the clearance closure values are not necessarily representative of those in later engine models.

Figure 7-2 Maximum Clearance Closures - Maximum closure in the fan occurs during maximum gross weight take-off (A) and in the first-stage high-pressure turbine during midclimb (B).
(J26090-2)

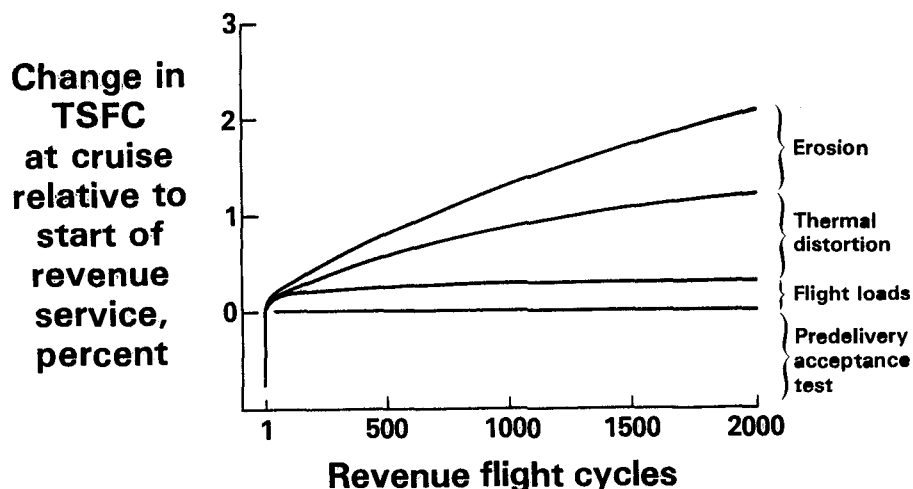
Figure 7-3 JT9D-7 Engine Performance Deterioration at Cruise - Predicted performance deterioration indicates a 2.1 percent increase in cruise thrust specific fuel consumption at 2000 revenue flights of an unrepaired engine. (J26216-21)

The current Boeing 747 production aircraft acceptance test procedure, assuming a nominal engine build, is estimated to cause an initial increase of 0.8 percent in engine cruise thrust specific fuel consumption prior to aircraft delivery. Up to 0.2 percent additional cruise thrust specific fuel consumption increase can be expected in the first 50 revenue flight cycles depending on the airplane gross weight in that service. Finally, additional gust- and maneuver-induced aerodynamic loads can be expected to increase the rub-induced JT9D performance loss during revenue service to 0.3 percent in 2000 flight cycles.
